Project name: HumSS- replace copper standing seam roof including fascias and soffits.

Quick facts	
Project value	£1,725,000
Client name	The University of Reading
Work start date	June 2013
Completion date	March 2014
Project manager	Dave Tingle, AED ☎Ext 💻 @reading.ac.uk
Wren no., Building name, building no.	1165084, HumSS, W001

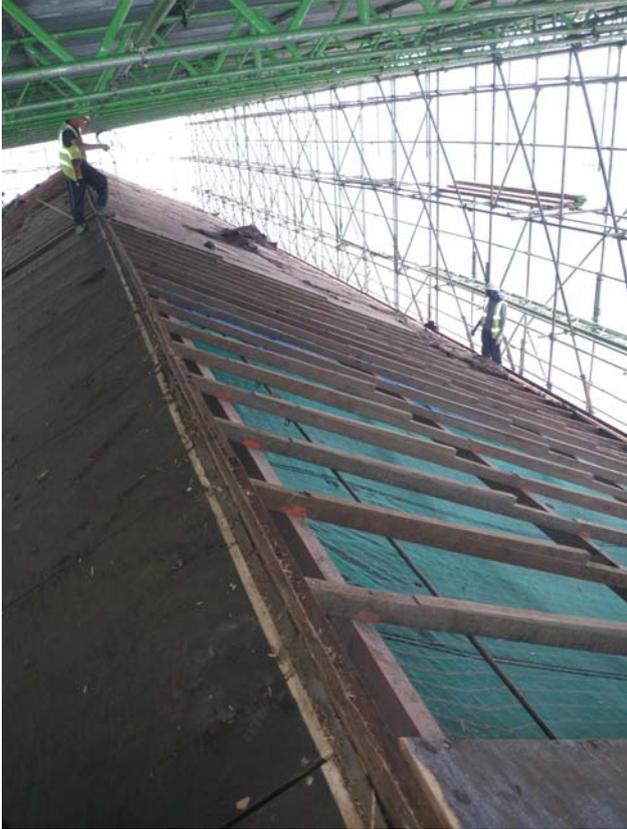
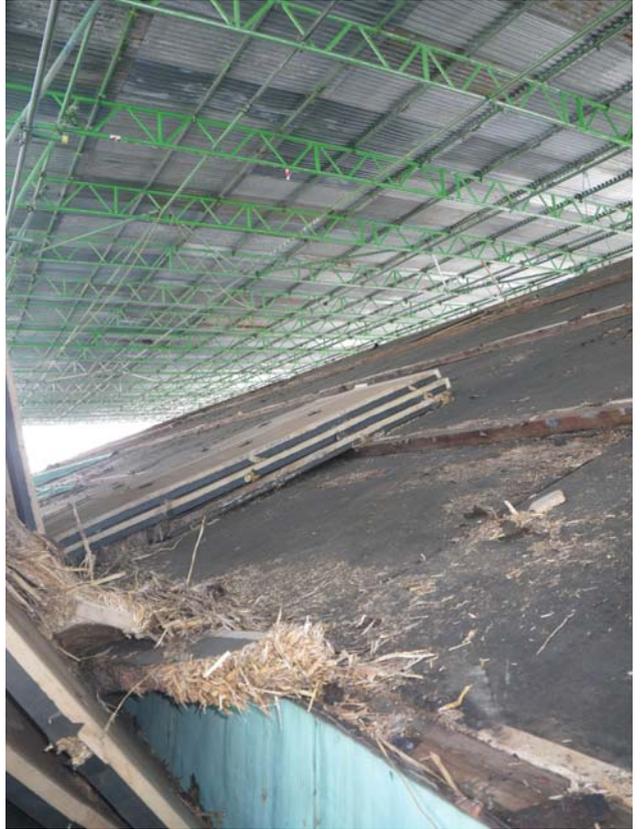
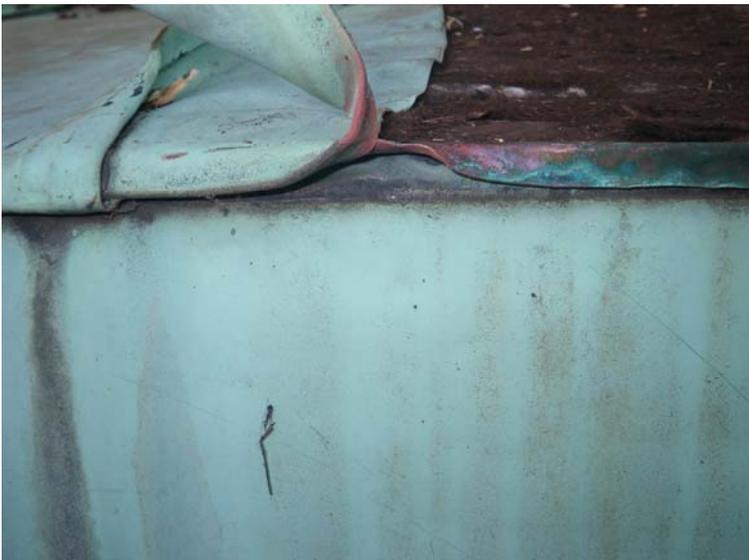
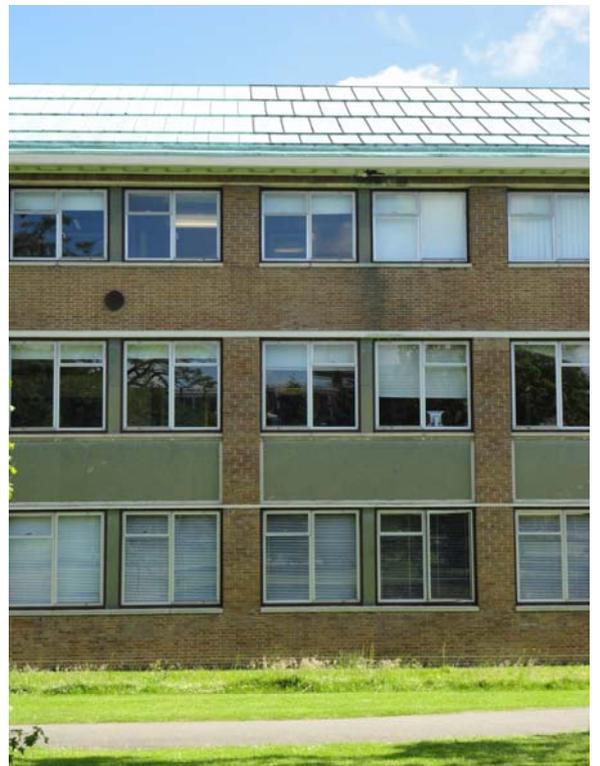
Before:

Existing situation: The copper roof on the HumSS building had reached the end of its life. As old as the 50 year old building, the copper suffered from general weathering, specifically acid rain which created pin sized holes in the copper that allowed water to get through to the wood wool boards underneath. Water and moisture caused the wood wool to weaken and water then entered the fabric of the building. Various options for replacement of the roof were considered and zinc, though not the cheapest, was considered to be the best replacement option for matching the same roof profile.
