Project name

Drainage works to alleviate flooding in the vicinity of the Engineering building.

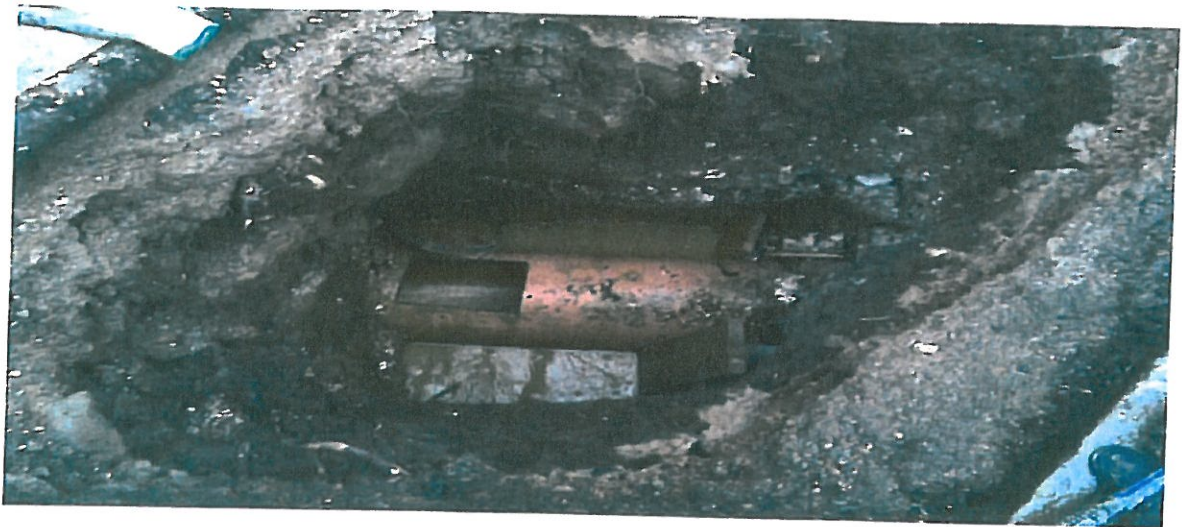
The locations of the blockages were identified by the CCTV survey. Access was cut into the drain (left photo) to expose and allow access to the blockage. The debris shown in the photo on the right is a tree root that was blocking approximately 50% of the bore of the drain. This section of drain was repaired with concrete and lined.

Access was cut into the drain (above) to free a blockage. The debris shown below is a tree root that was blocking approximately 50% of the bore of the drain. This section of drain was repaired with concrete and lined.

A CCTV survey was carried out to assess the condition of the drain. Numerous defects were found. Pitch Fibre sections of drain were lined. Two blockages were removed – a tree root and aggregate from a past aborted attempt to connect into the drain. Alterations to car park kerb stones outside Engineering were made to guide surface water into gulleys.
